Phoenix Award for Excellence in Reconstruction

Hickory Creek Apartments

By Dale Sharp, and Casey M. Geisler

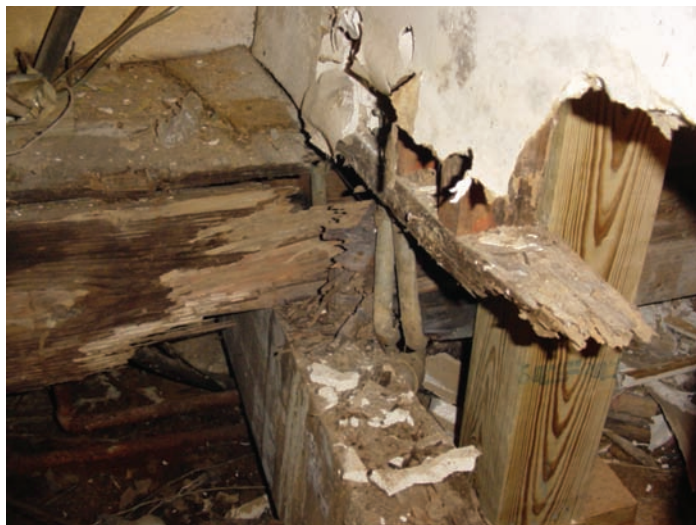
(Far left): As a result of settlement and improper placement, the originally installed beams and plates were subject to much deterioration. Over the years, settlement created stress on many plumbing connections. The resulting leakage caused decay and rot to occur.

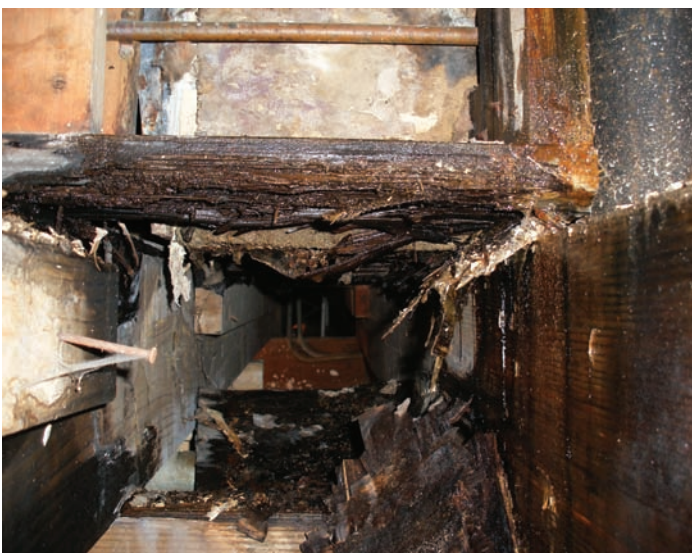
(Bottom left): This view down the length of the original beam shows the typical conditions prior to reconstruction.
