Decay of Log Home

APPRAISER'S STATEMENT

This Appraisal Report is based on the existing log home located at 1151 Sugar Plum Drive, Moncks Corner, South Carolina. The purpose of the Appraisal Report is to give an opinion on:

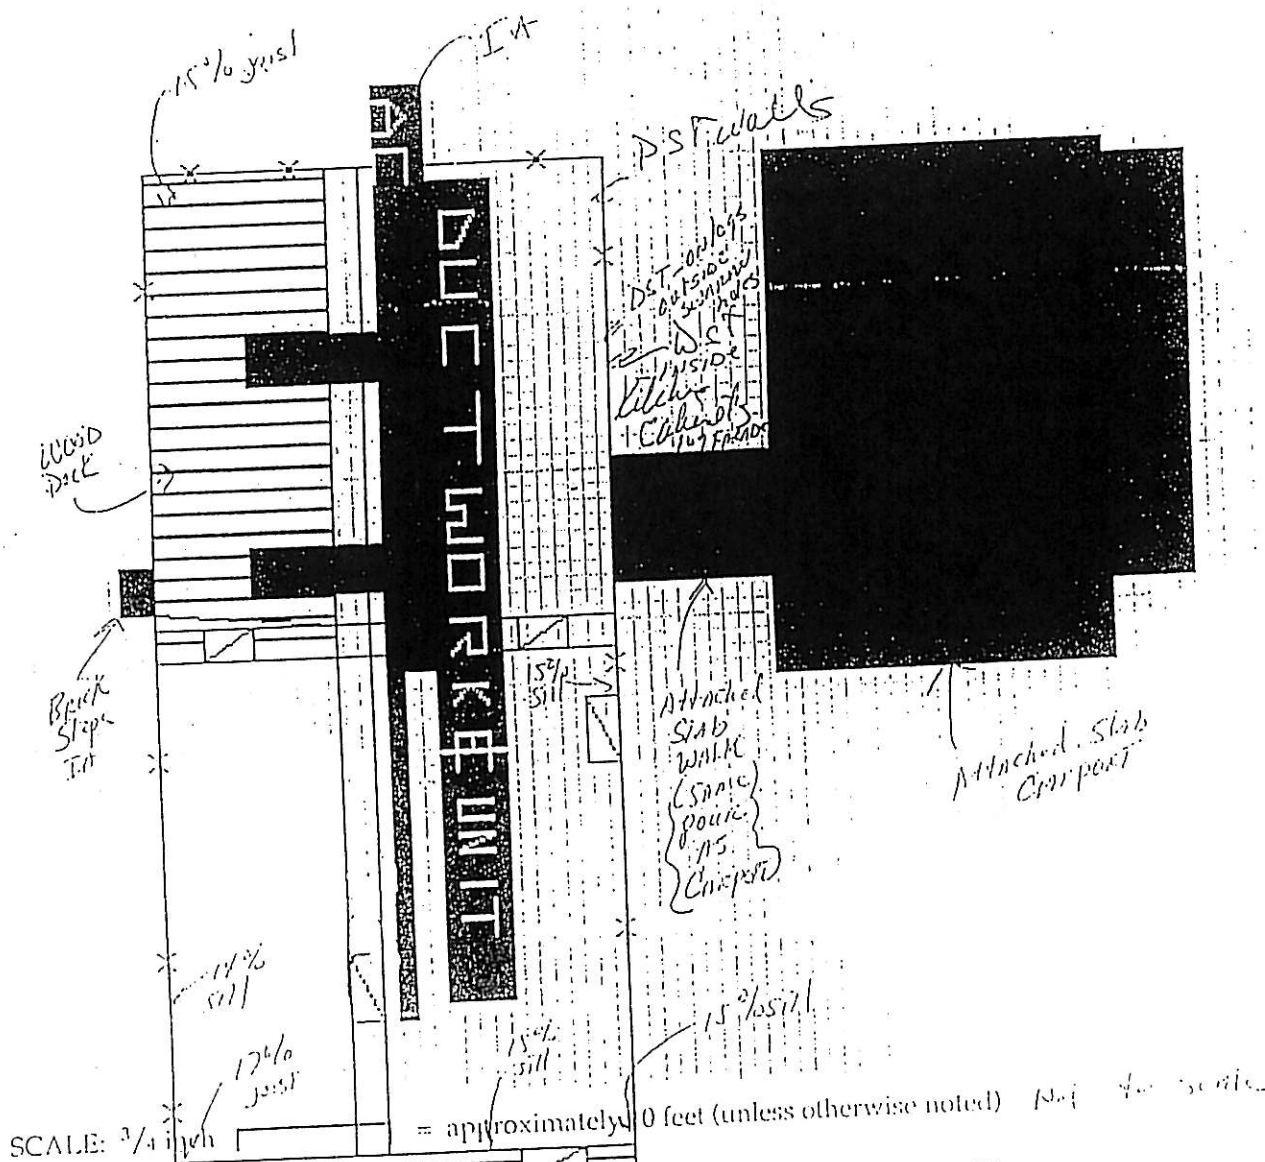
Wood Destroying Organisms Activity And/Or Damage Graph

Partially scraped subterranean termite shelter tubes and subterranean termite damage was present in the back center of the house (inside a kitchen cabinet on the log facade) and in the back left room on the log facade. This structure is a log cabin, with the inside walls being finished logs.

Excessive moisture levels, active decay, and decay damage were present on the outside facade (which is a log cabin), which was restricted to areas immediately surrounding cracks,

checks, and other openings in the logs where rainwater had penetrated. Decay damage was most severe in the area to the rear of the kitchen door at the right side of the structure; a significant fraction of the roof runoff is directed onto this area by the design of the building and is the most likely cause of the decay damage. Similar, but less severe, damage exists in the area in front of the kitchen door and in a few other small areas where large amounts of runoff are directed onto the logs.

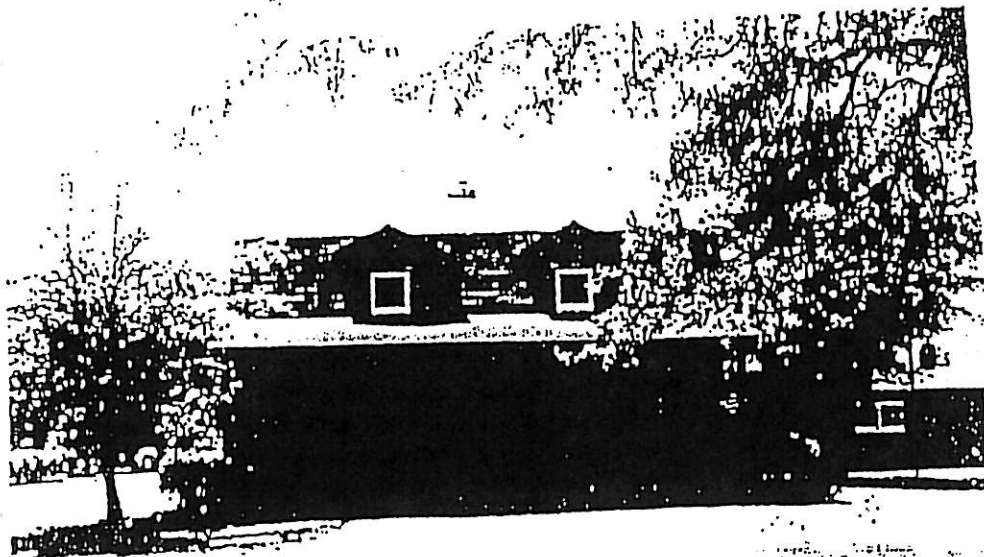
FIGURE 1

Figures 1 and 2 are views of the front (east) side of the log home; Figure 3 is a view of the south side of the home; Figures 4 and 5 are views of the west side of the home; and Figure 6 is a view of the north side of the home. The exterior of the home appeared to be in good overall condition, though normal checking cracks had developed in the pine logs. A clear sealant had been applied to some of the cracks and joints reportedly caused as result of Hugo, to prevent water from entering the building. Note, it is M.E.A.'s understanding that it had been claimed that several of the exterior walls had also shifted or bowed as a result of Hugo, contributing to the water leakage problem. Though M.E.A. did confirm the presence of several alignment abnormalities with the log walls, the physical evidence clearly indicated these phenomena resulted from minor construction deficiencies and not Hugo.

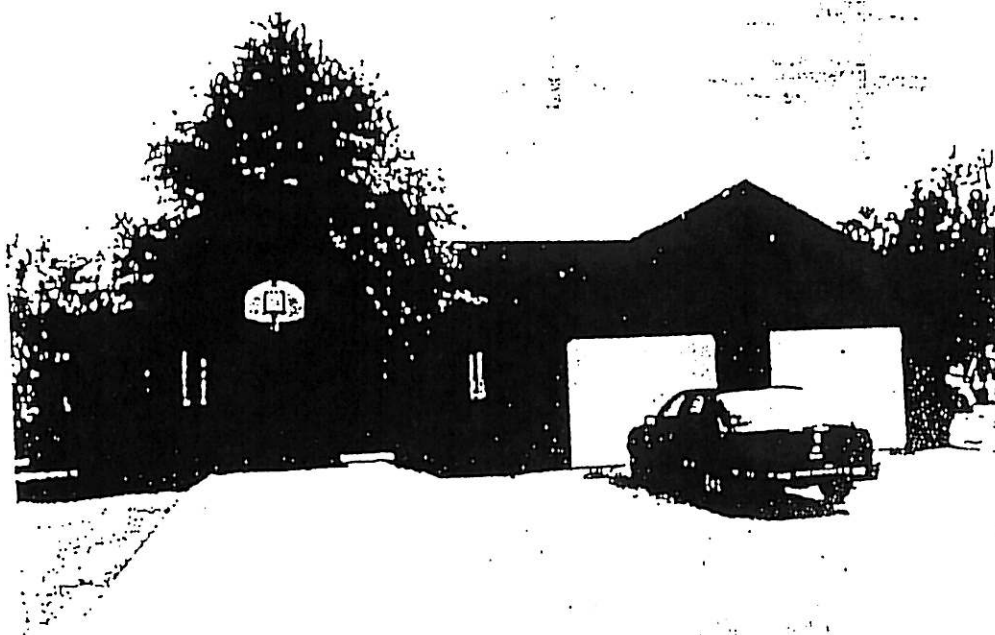
FIGURE 6

The Breezeway was part of the log cabin package designed by Products, Inc. purchased by Mr. Oxford. A portion of the Breezeway can be seen in Exhibit I. This xerox copy is a portion of the second floor from the original plans that were viewed at Attorney Mennis' office (the Breezeway lines were enhanced due to the fact that the blueprint has faded). Each side of the Breezeway that attaches to the Main House displays various stages of wood decay (See Photographs 6, 7, and 8). The termite shelter tubes that were visible in the Kitchen and Son's Bedroom are located in the same general area of the interior as the exterior displaying various stages of wood decay. Looking at the opposite end of the Breezeway where it attaches to the Garage no decay is visible. "Water run off" management and the omission of a water repellant product on the exterior surface contributed to the advanced stages of the North Elevation log decay as viewed in Photograph 6.

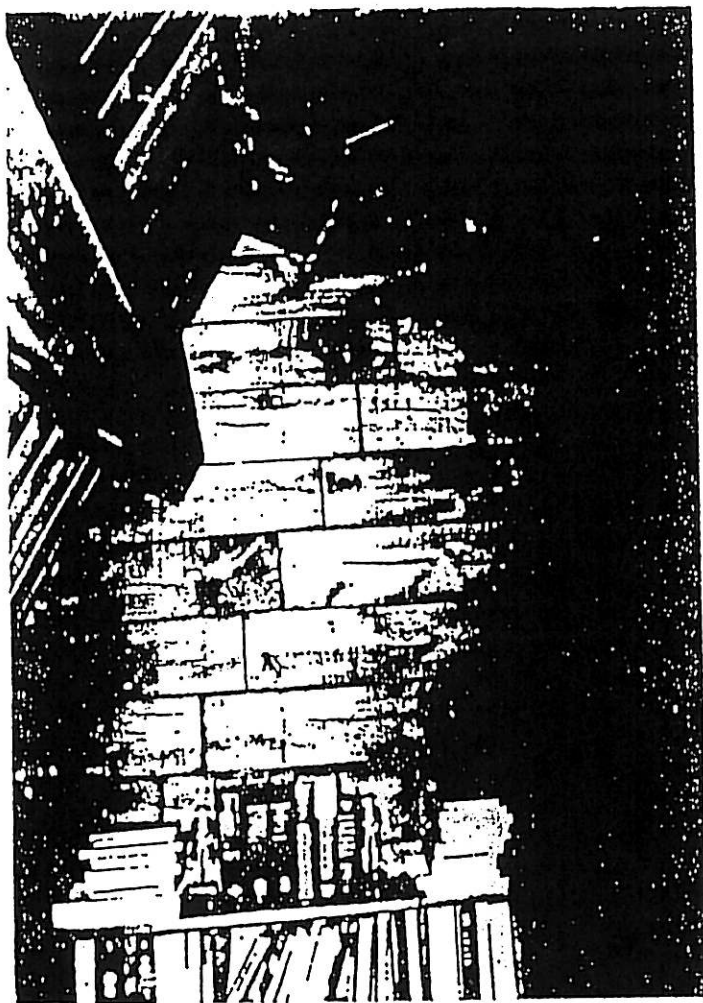
FIGURE 29

Figures 29 through 35 are various interior views showing the typical checking cracks, butt joints, and water stains. The water stains appeared to occur at random locations and were fairly prevalent throughout the interior of the home.

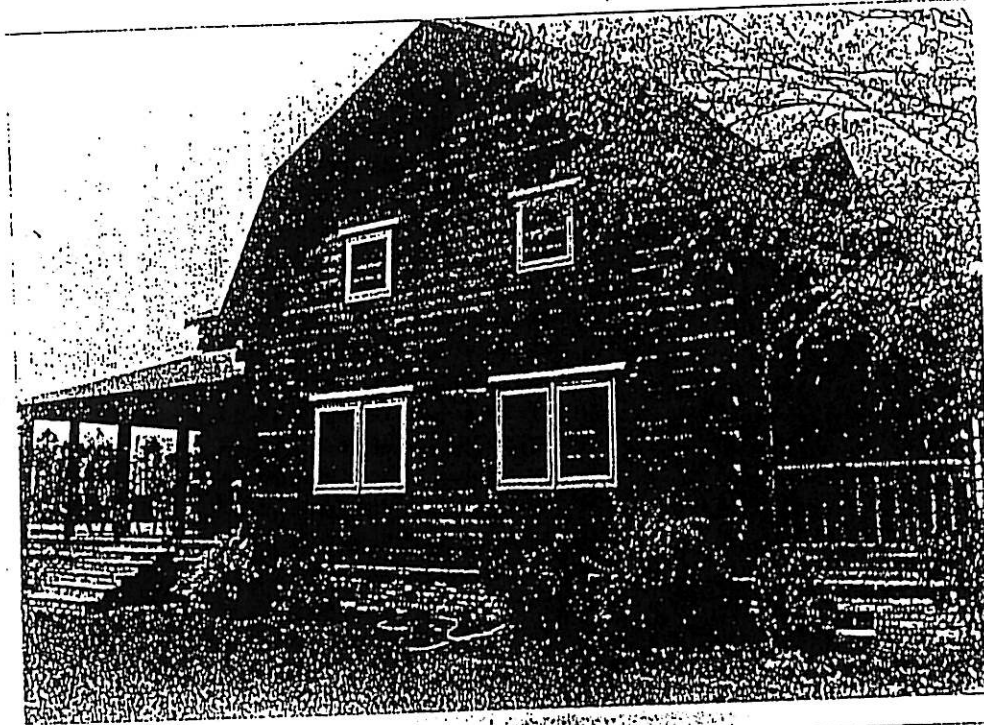
UPPER PHOTO: View of the gabled end of the house showing the configuration of the logs and gambrel roof. The majority of the leaks are coming in through the gabled end walls.

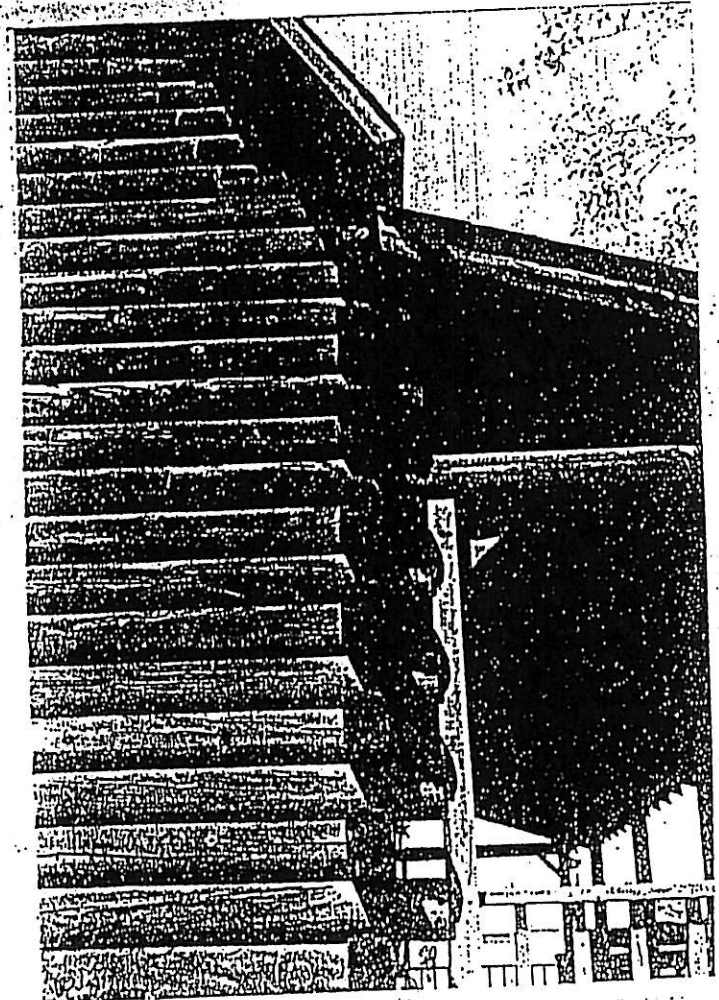
LOWER PHOTO: View of the corner of the house showing the interconnection of the logs. Many of the ends of the logs show large checks.
