**Furnace Blow Back
at
High School**

Charles M. Smith, II, CR

January 1996

RESTORER'S STATEMENT

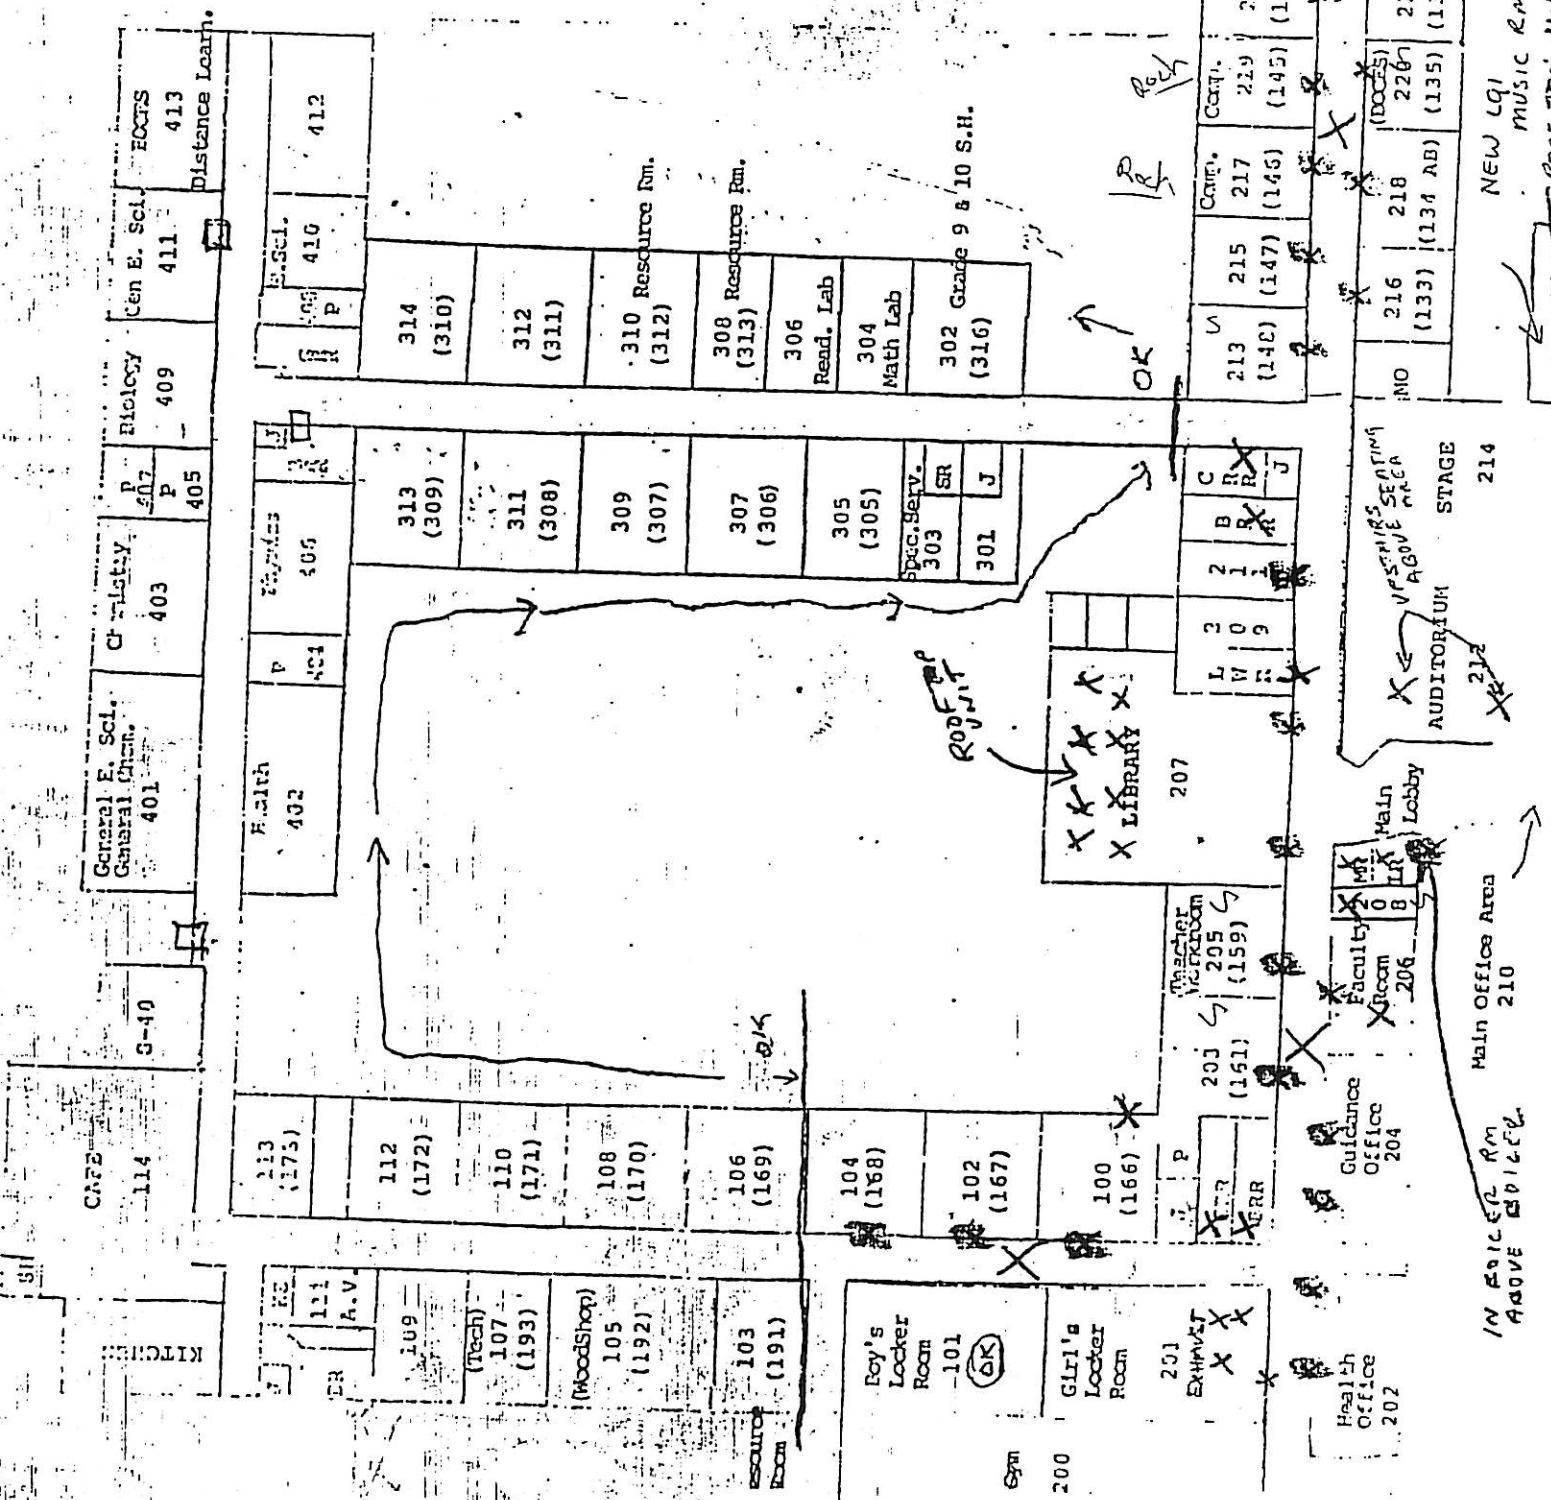
HIGH SCHOOL
FLOOR LAY OUT

It appears from my examination and visual inspection, that the smoke migrated from the basement furnace room into the hallway and adjacent offices. Throughout the hallway are ventilation grills which allow air to move freely from the halls to the classrooms. These provided the passageway for the air born particulates contained in the smoke to move into the classrooms. (See diagram for location of ventilation grills.) PHOTOGRAPH 12-14 show grills.
