Roof Inspection Survey

John J. Basso, CR

September 1992

ROOF INSPECTION SURVEY
1150 Plant St.
Winter Garden, Florida

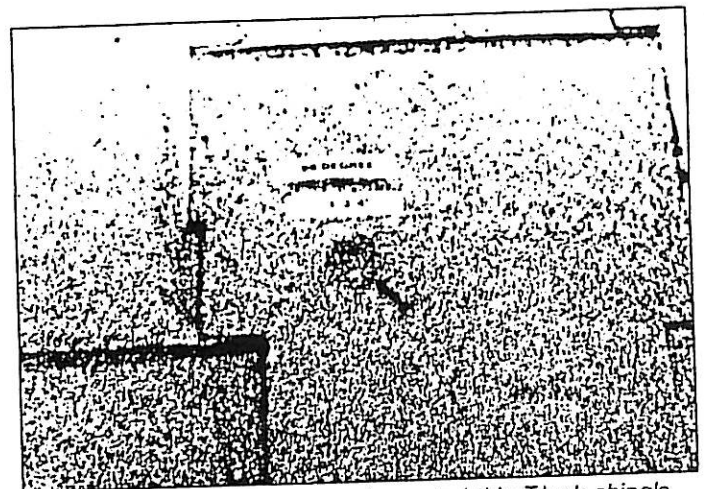
ficial, with just minor granule loss. It was observed in some shingles, such as Target No. 1, that indentations would occur (hail size of 2 inches or 51 mm, 90-degree angle). At this point, the shingles were desaturated with hot solvent, and fractures were observed in the shingle mat. These fractures were not readily detected by visual observation.

Photo 4: A 1 3/4-inch hailstone impacted this T-lock shingle at a 90-degree angle.

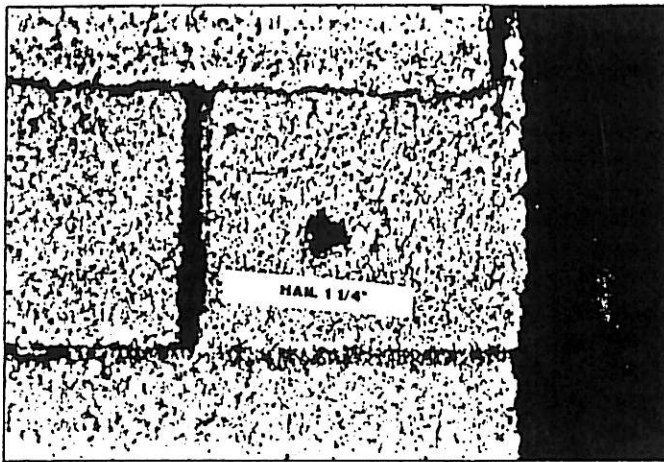
The older, organic three-tab and T-lock shingles exhibited a very low threshold of hail resistance (see Photo 5). As shingles age, asphalt within the shingle obviously hardens and becomes somewhat more brittle. This creates a situation in which tow residences could be next door to one another, and one residence could sustain damage to a slightly older roof, while the other residence could have virtually no damage with a new roofing system.

Photo 5: 1¼-inch hailstones impacted on an older, three-tab shingle.

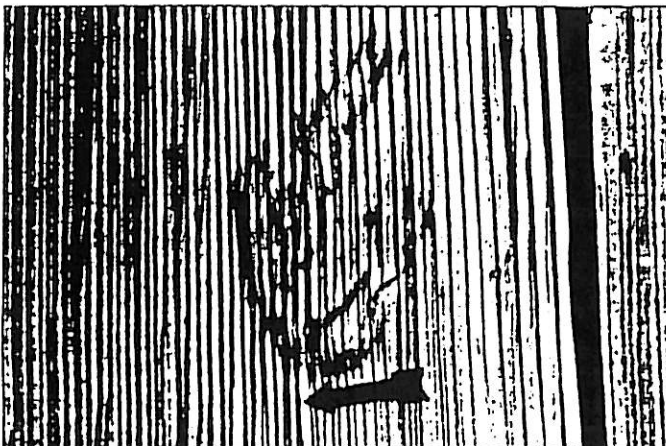
When the wood shingles (Targets No. 15 and 16) were impacted with hailstones 1 ¼ inches (44 mm) or larger, the shape of the indentation was not uniform (see Photo 6). This was due to two factors: One, the

Photo 6: Irregular indentation of hailstone impacted on a wood shingle.

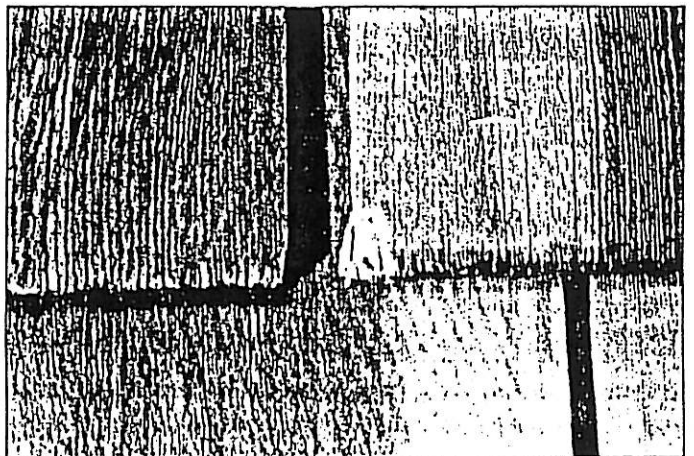
The thicker wood shingles did not necessarily result in higher hailstone resistance. The thinner red cedar shingles (¾ inch or 9.5 mm) with smoother surfaces and a greater uniformity in the substrate produced hailstone resistance equal to the thicker shingles. Some indentation of the wood shingles did occur at the leading butt edge and at the joint of the shingles. The bulk of this damage is somewhat superficial, and began at a fairly low threshold of kinetic energy (see Photo 7).

Photo 7: Wood shingle indentation at butt edge.

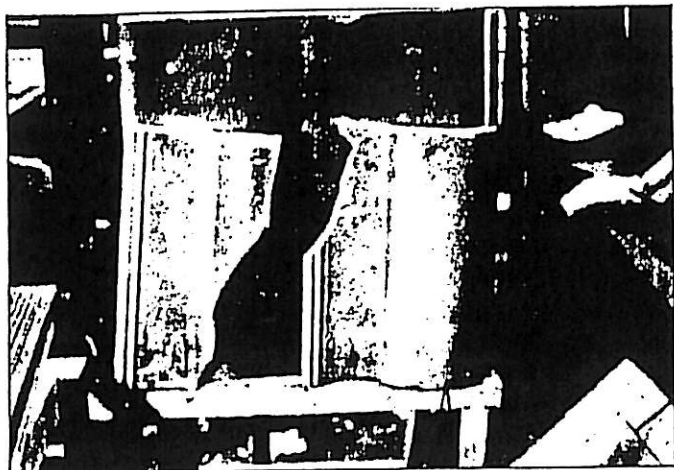
The three concrete tile targets all exhibited fairly high degrees of hail resistance. Fracture/breakage did not occur with the 2 ½-inch (64-mm) hail at a 90-degree angle of impact. Fracture/breakage did occur, however, when the velocity was increased to 131 feet per second (40 meters per second) or 89 mph, resulting in kinetic energy of 71.49 feet per second (96.9 joules—see Photo 8).

Photo 8: Fracture of a concrete tile.
