Phoenix Award for Excellence in Reconstruction

Hickory Creek Apartments

By Dale Sharp, and Casey M. Geisler

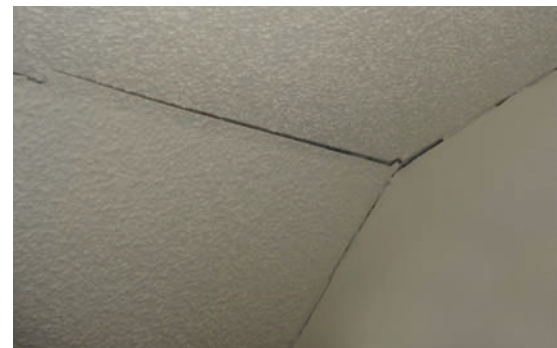
(Below): The settling of the building was evidenced in many ways. The cracks in these interior finishes were fairly typical in the corridors.
