Roof Inspection Survey

John J. Basso, CR

September 1992

ROOF INSPECTION SURVEY
1150 Plant St.
Winter Garden, Florida

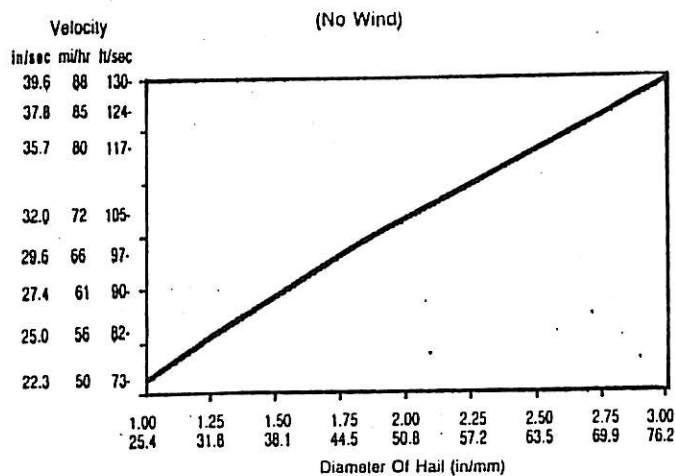
Figure 1: Terminal velocities of hail.

4. *Terminal velocity:* The terminal velocity of hailstones was originally determined by J.A.P. Lauri. These terminal velocities (see Figure 1) have been used throughout the industry in other research, particularly that performed by the National Institute of Standards and Technology (formerly the National Bureau of Standards).

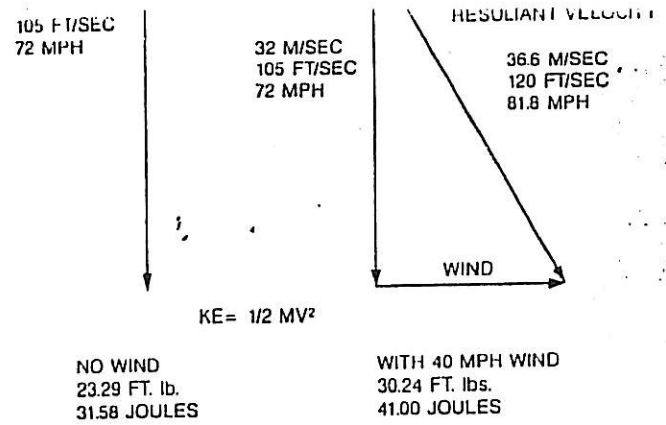
Figure 2: Effect of 40-mph wind on 2-inch-diameter hail.

An example would be a 2-inch (51-mm) hailstone that would have a free-falling terminal velocity of 105 feet per second (32 meters per second) or 72 mph. If this stone was associated with a 59-feet per second (54 meters per second) or 40-mph horizontal wind, the resultant terminal velocity would increase to 120 feet per second (36 meters per second) or 82 mph.

The overall increase in kinetic energy would be from 23.29 pound force (31.58 joules) to 30.24 pound

force (41.0 joules), or an increase of 30 percent in impact energy. By varying the horizontal wind factor, the ultimate impact energy can be varied dramatically (see Figure 2).

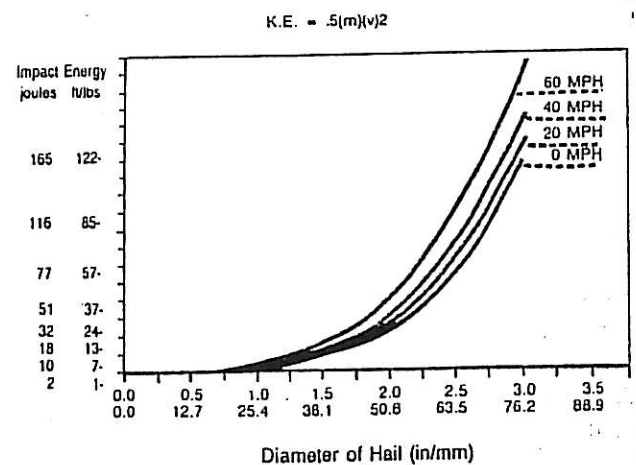
Figure 3: Impact energy of hail.

In reviewing this initial data, it is also interesting to note the overall difference in impact energy between hailstones with diameters of 1 inch (25.4 mm) and 2 inches (51 mm). Increasing the diameter of the hail from 1 inch to 2 inches increases the ultimate impact energy from less than 1 foot per pound (1.4 joules) to approximately 22 foot per pound (29.83 joules—see Figure 3).

The approximate impact energy obviously increases on an exponential scale, which is determined by the mass and the increase in terminal velocity. These two factors, mass and velocity (which are both increasing exponentially), cause a dramatic increase in the impact energy with small, incremental fluctuations of hail diameters.

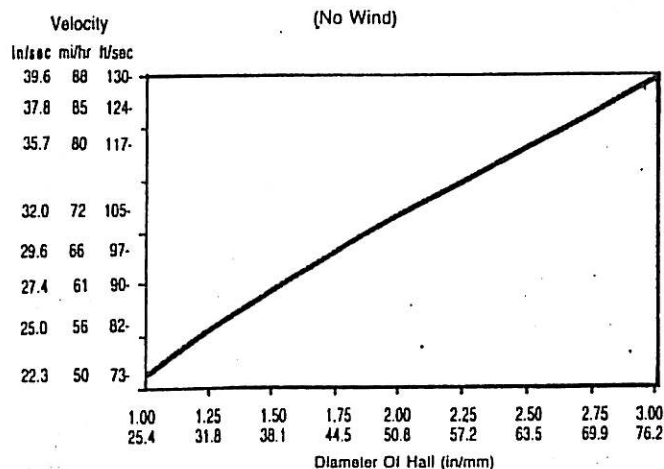
Figure 1: Terminal velocities of hail.

4. **Terminal velocity:** The terminal velocity of hailstones was originally determined by J.A.P. Lauri. These terminal velocities (see Figure 1) have been used throughout the industry in other research, particularly that performed by the National Institute of Standards and Technology (formerly the National Bureau of Standards).

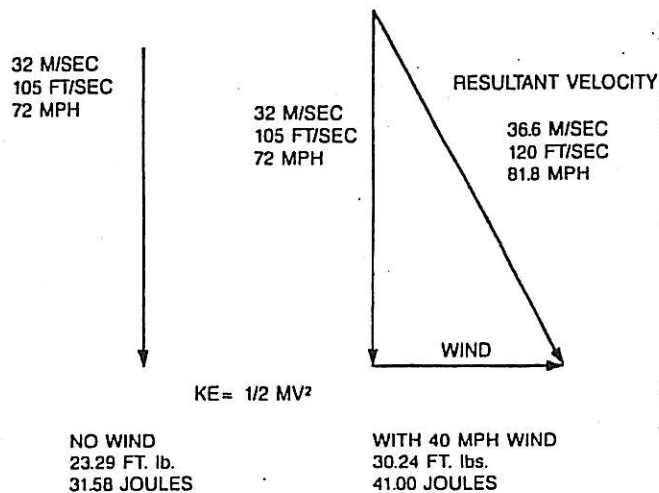
Figure 2: Effect of 40-mph wind on 2-inch-diameter hail.

An example would be a 2-inch (51-mm) hailstone that would have a free-falling terminal velocity of 105 feet per second (32 meters per second) or 72 mph. If this stone was associated with a 59-feet per second (54 meters per second) or 40-mph horizontal wind, the resultant terminal velocity would increase to 120 feet per second (36 meters per second) or 82 mph.

The overall increase in kinetic energy would be from 23.29 pound force (31.58 joules) to 30.24 pound

force (41.0 joules), or an increase of 30 percent in impact energy. By varying the horizontal wind factor, the ultimate impact energy can be varied dramatically (see Figure 2).

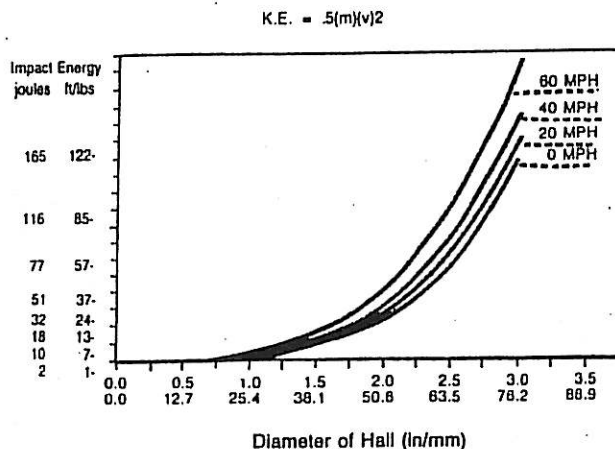
Figure 3: Impact energy of hail.

In reviewing this initial data, it is also interesting to note the overall difference in impact energy between hailstones with diameters of 1 inch (25.4 mm) and 2 inches (51 mm). Increasing the diameter of the hail from 1 inch to 2 inches increases the ultimate impact energy from less than 1 foot per pound (1.4 joules) to approximately 22 foot per pound (29.83 joules—see Figure 3).

The approximate impact energy obviously increases on an exponential scale, which is determined by the mass and the increase in terminal velocity. These two factors, mass and velocity (which are both increasing exponentially), cause a dramatic increase in the impact energy with small, incremental fluctuations of hail diameters.

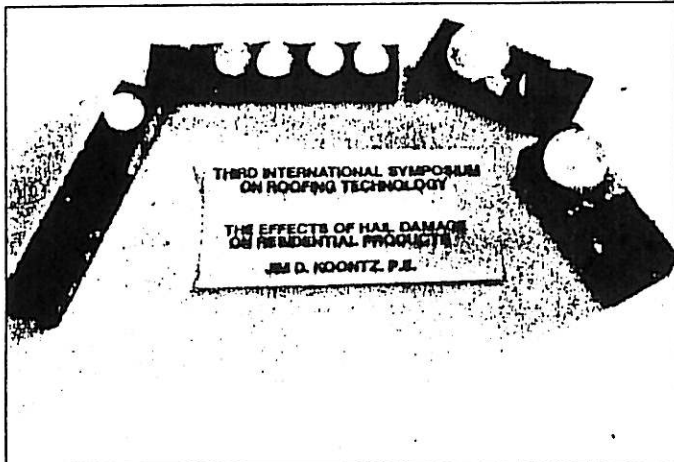
Photo 2: Hail molds.

This gun consisted of a pressurized air tank fitted with a quick-release, electronically actuated valve (see Photo 1). The barrels of the hail gun were interchangeable to accommodate the size of the hail, which was formed in molds (see Photo 2).

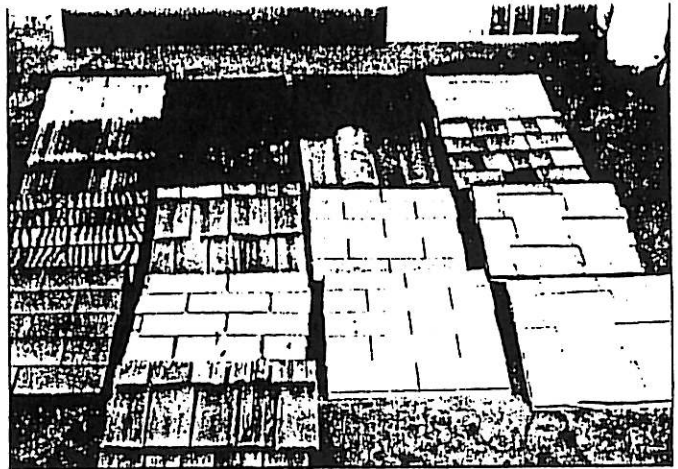
Nineteen roofing assemblies were tested for resistance to hail damage (see Photo 3). The substrate of 18 of the samples was $\frac{1}{2}$ -inch (12.7-mm) CDX plywood. One sample was tested with $\frac{1}{2}$ -inch (12.7-mm) OSB decking.

Photo 3: The hail targets.

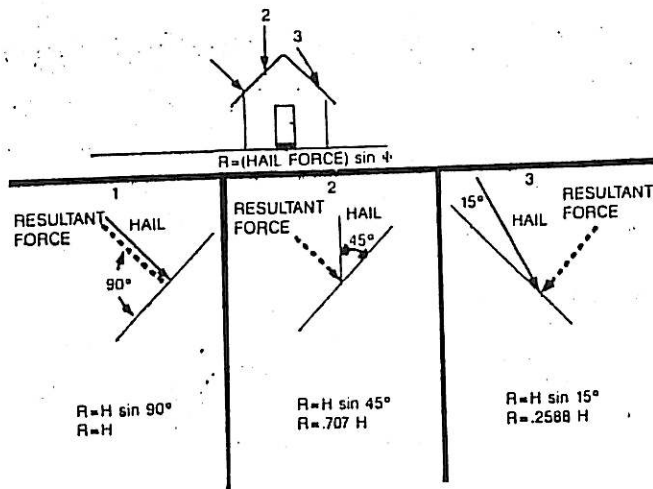
Figure 4: Angle of impact of hail.

Each sample was impacted by hail 15 times. This included five different sizes of hail— $\frac{1}{8}$ inch (19 mm), $\frac{1}{4}$ inch (32 mm), $\frac{3}{8}$ inch (44 mm), 2 inch (51 mm) and $2\frac{1}{2}$ inch (64 mm)—impacting at three different angles of impact (15, 45 and 90 degrees—see Figure 4). A variation in the angle of impact from 15, 45 to 90 degrees produces a resultant force ranging from 25.88 percent, 70.7 percent and 100 percent, respectively.
